**Report to the
Township of Madawaska Valley
for the Condition Assessment of
the Water System**

Date: December 9, 2020

Project No: MADVAY5972-2022

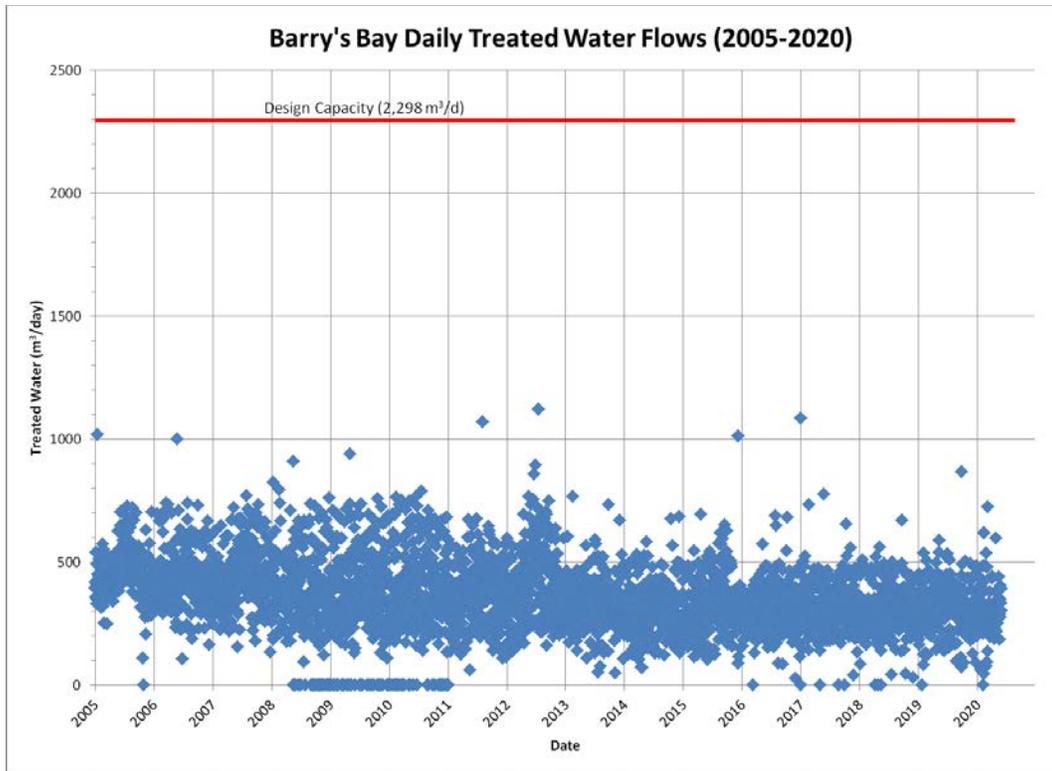
Figure 1: Barry's Bay Treated Water Flow History (2005-2020)

Figure 1 shows the historical water demand in comparison to the plant's design capacity. The average flow for the past 15 years is 364 m³/day, while the plant has a capacity to produce 2,298 m³/day. Plant production capacity must always exceed water demand to prevent shortages and low-pressure events in the distribution system. Water treatment capacity expansion is a consideration when the average flow is between 70-80% of design capacity. At present, average flow is at 16% design capacity.

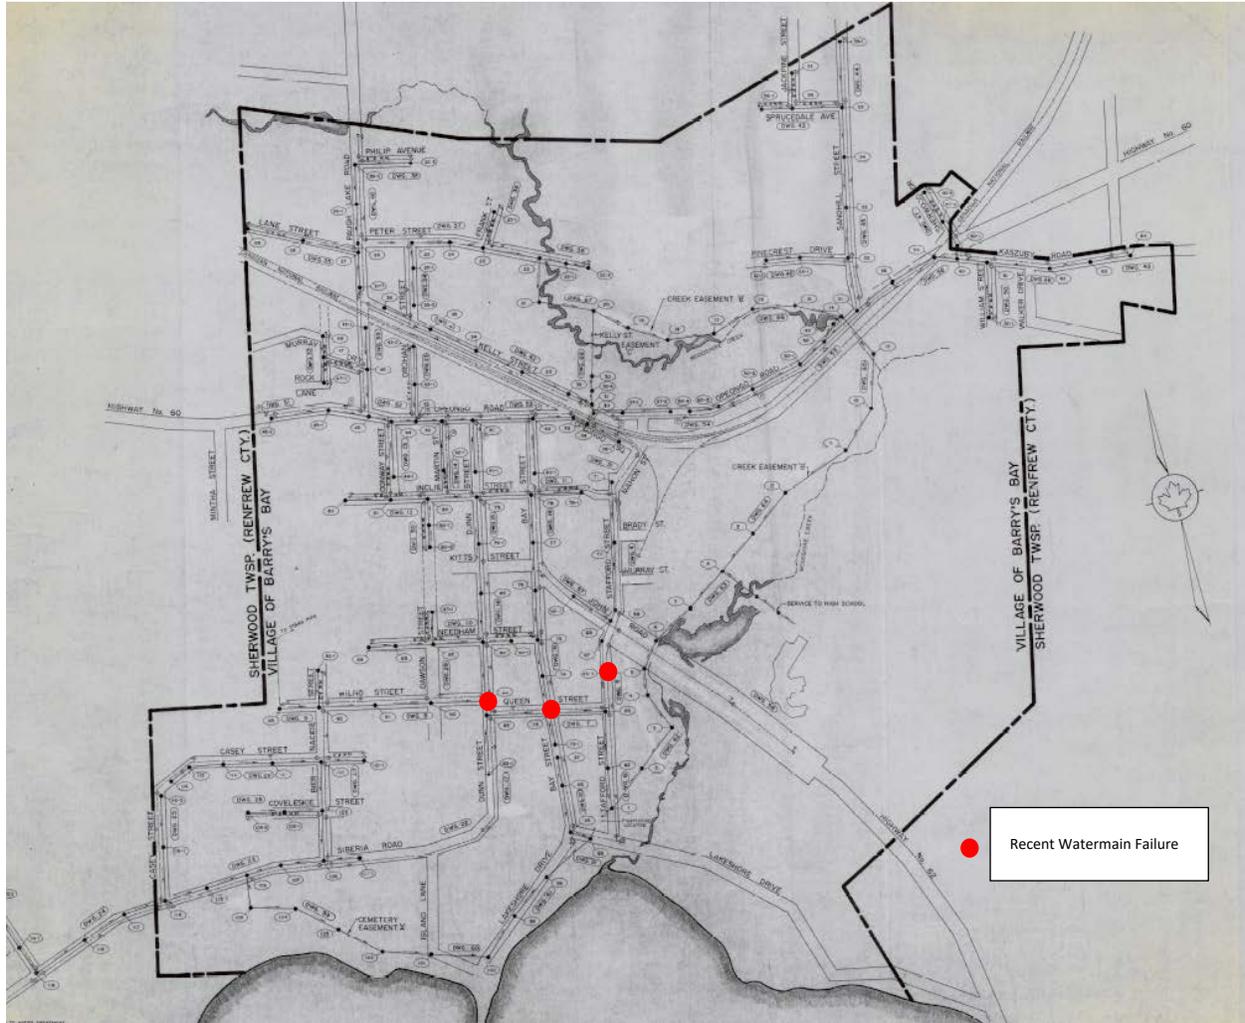
Watermain Schematic

Figure 2: Water System Schematic
